Monitoring Study Group Meeting Minutes

May 19, 2004

Western Mendocino County

Field Tour to Observe and Discuss Watercourse Crossings

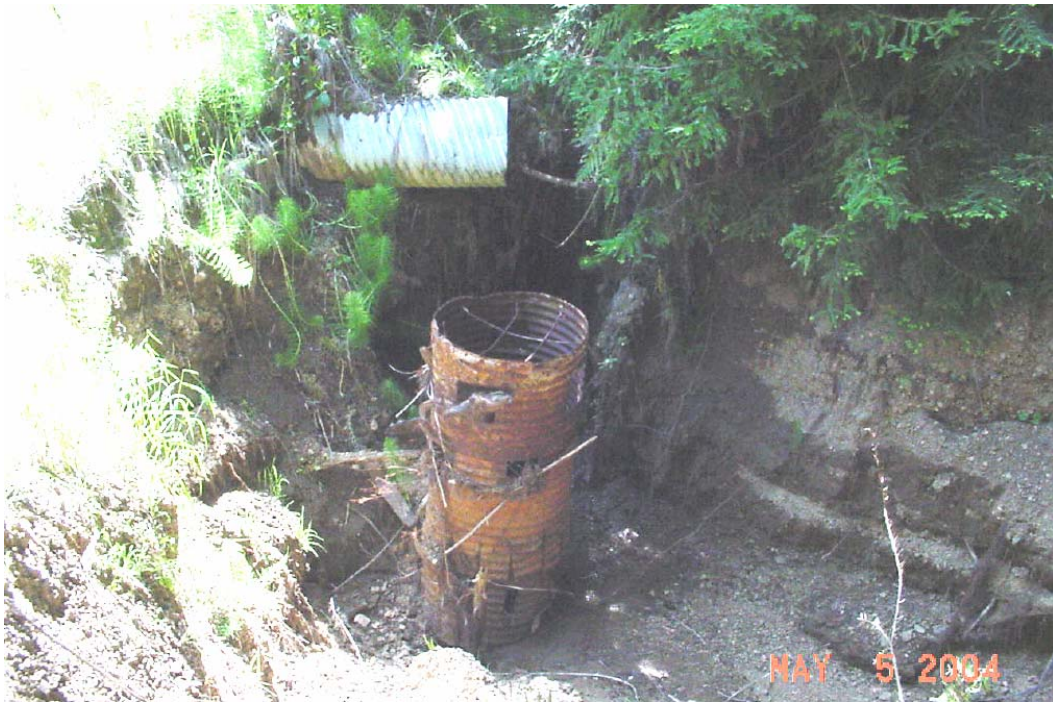
Stop 1. Jackson Demonstration State Forest (JDSF)—Sindel Gulch, James Creek watershed, Road 111 (Figure 1). John Griffen stated that this portion of James Creek, a tributary of the North Fork of Big River, was first harvested in the mid-1950's with crawler tractors. Road 111 was built in 1979 for the second harvest entry. A CDF inspection in 1979 noted numerous violations of the Forest Practice Rules (FPRs) associated with the 1979 timber sale. Violations were issued and corrective measures undertaken but significant amounts of erosion occurred related to road and landing construction. Based on recommendations by CGS (formerly CDMG) engineering geologist Mike Huffman, a perforated standpipe was placed on the 36 inch CMP installed for the Class II watercourse to allow water to enter the pipe as sediment in the channel buried the pipe inlet, and a 24 inch CMP was installed much higher in the road prism as an overflow pipe. This configuration worked for approximately 20 years, but eventually material overtopped the inlet of the standpipe and during the winter of 2001/2002 water overtopped the road, resulting in erosion at the outlet. In 2002, a backhoe excavated the sediment basin and exposed the top two-thirds of the standpipe structure. Headcutting occurred in the channel in 2003 and 2004, and by the spring of 2004, the channel had downcut back to the original pipe elevation, flushing large quantities of sediment downstream.

Figure 1. JDSF (stop 1). Old perforated standpipe, overflow CMP and excavated channel in a James Creek tributary.

There was considerable discussion about how to improve the existing situation. The lower 36 inch culvert is in need of replacement and a much larger pipe would be required under the current FPRs. It was the consensus of the group that the best solution is to properly abandon the crossing and mid-slope road system. Tom Spittler stressed that an assessment of the hillslope erosion problems present in the basin and survey of existing sediment storage in the channel above the crossing should be completed prior to determining an engineering solution if the crossing is to be reconstructed. Sediment catch basins can be installed but must be adequately maintained indefinitely.

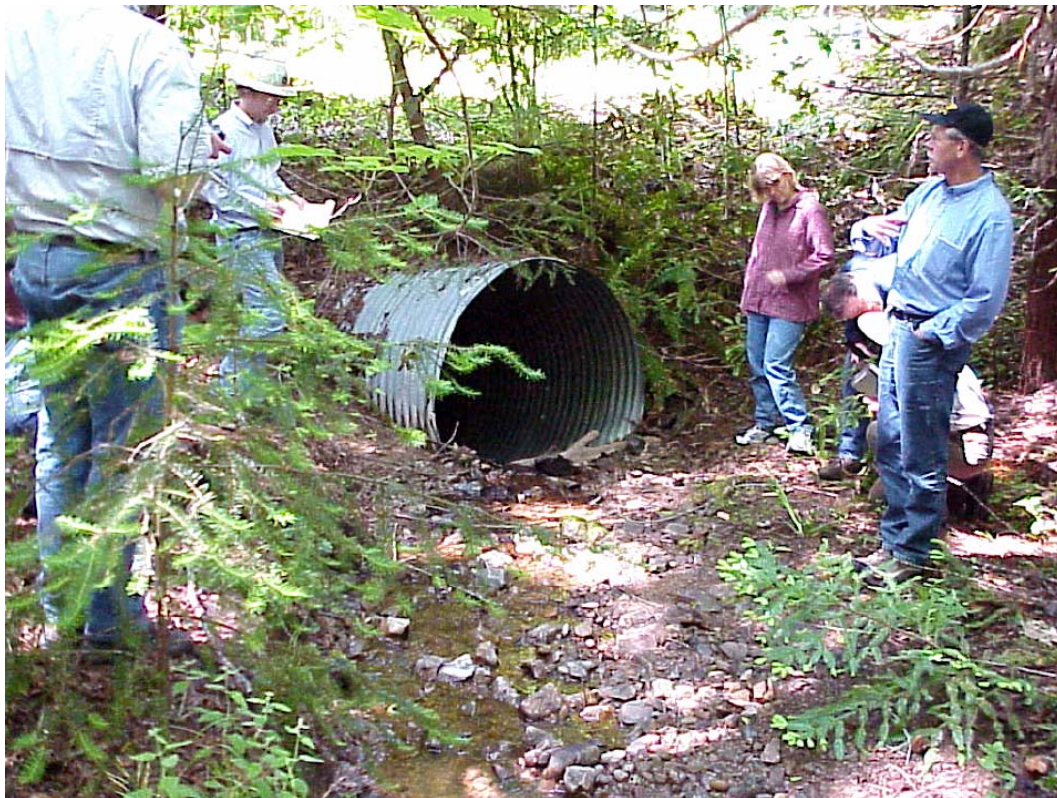
Stop 2A. Jackson Demonstration State Forest (JDSF)—Sindel Gulch, James Creek watershed, Road 110 (Figure 2). The group observed an existing 60 inch CMP lower down on the same Class II drainage as the structure described above. John Griffen stated that this pipe appears to have been installed for a timber sale that took place in the James Creek drainage in the mid-1980's. A piece of large wood at the culvert entrance is currently blocking the lower part of the pipe inlet, causing abundant sediment storage upstream. A considerable amount of water is flowing under the pipe and an old sediment terrace (probably at least 20 years old) indicates that the pipe (or previous pipe) has been overtopped in the past. It was agreed that if the pipe is removed as part of a road abandonment project, the huge load of sediment in the channel will destabilize and move down into fish bearing waters below. Therefore, Tom Spittler and Dave Hope suggested that the best alternative would be to build grade control structures in the channel. Based on future documentation of channel conditions, one way to do may be to install jetty size (2 ton plus) boulders, preventing a quick pulse of sediment from moving downstream. Boulder grade control is far superior to other types of structures such as gabion baskets that degrade and tip over in the channel. Boulder grade control structures would mimic natural processes, leading to a step-pool channel configuration over time. Holly Lundborg stressed that if this pipe was included as part of a THP, it would have to be fixed to reduce a large potential sediment source area.

Figure 2. JDSF (stop 2A). 60 inch CMP with a heavily aggraded channel upstream of the inlet in a James Creek tributary (photo taken by Brad Valentine).

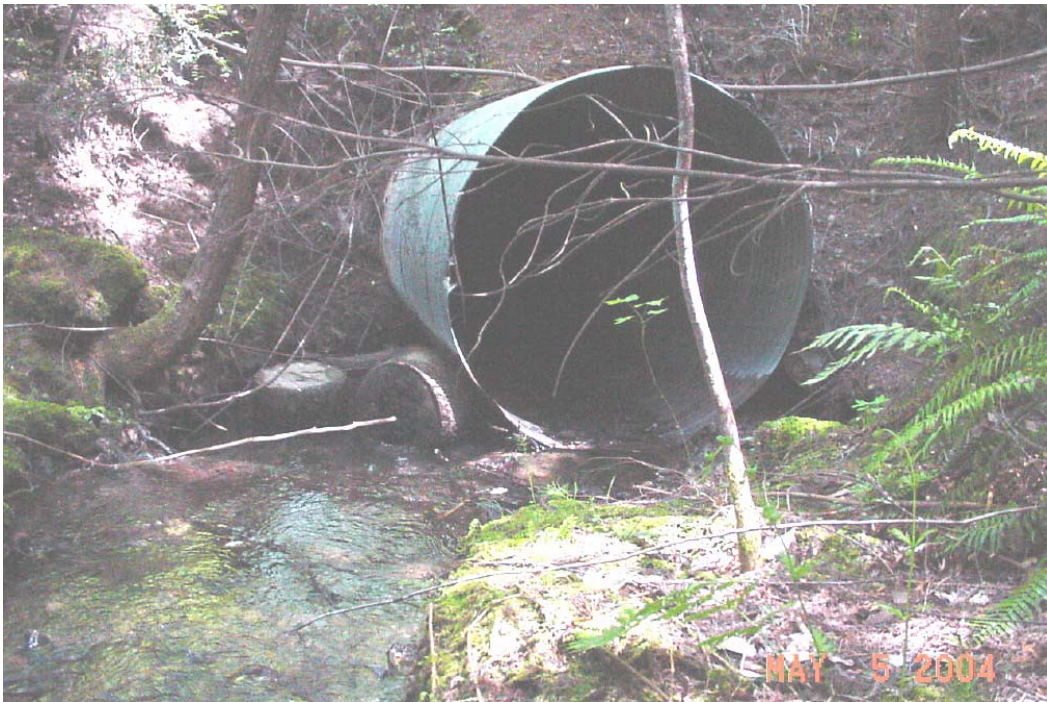
Stop 2B (Figure 3). Another older 60 inch CMP was observed on Road 110 in a nearby tributary draw. It is likely that this pipe is at least 40 years old and currently little water is flowing through the pipe due to heavy corrosion. John Griffen explained that typically pipes fail first at the lower end, the outer fill is lost, with fill erosion then working upstream towards the pipe inlet, often causing pipes to separate at joints. Clearly this pipe needs to be either replaced or the crossing properly abandoned. The Road Management Plan included in the JDSF Management Plan calls for inventorying all JDSF roads and crossings in a five year period to locate high risk sediment sites, such as those described above.

Figure 3. JDSF (stop 2B). Old corroded 60 inch culvert in need of replacement or removal in a James Creek tributary.

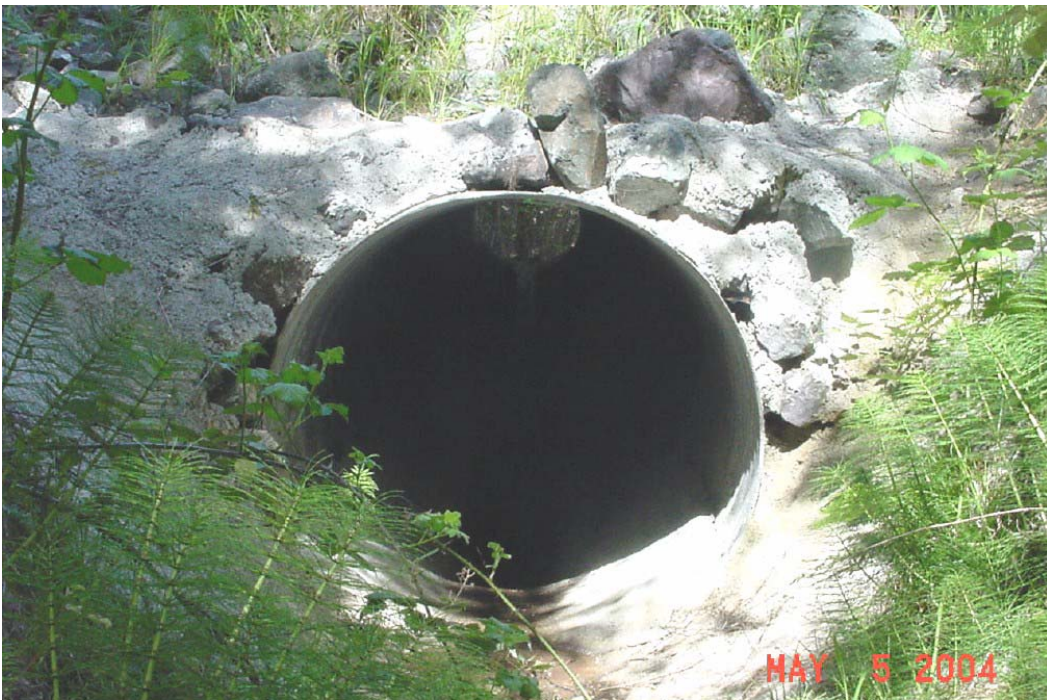
Stop 3. Jackson Demonstration State Forest (JDSF)—North Fork of James Creek Class II Tributary, Road 110 (Figure 4). We observed a site where two earlier culverts had failed due to abrasion from bedload sediment movement over the pipe bottom. John Griffen stated that the bottom third of the invert circumference of the existing 60 inch CMP was paved with concrete to protect the bottom of the pipe, and the rocked headwall was cemented to reduce inlet erosion potential four years ago. The total cost of installation (pipe, cement slurry, labor and equipment) was \$17,500. Rick Macedo cautioned that cement is extremely toxic to aquatic life and must be used very carefully in stream systems. It was also noted that a long inside ditch system delivers large quantities of fine sediment directly into this Class II watercourse. More frequent cross drain structures are needed or road improvement work that would remove the inside ditch, outslope the road, and install rolling dips--hydrologically disconnecting the road network from the channel.

Figure 4. JDSF (stop 3). 60 inch CMP in a North Fork James Creek tributary with cemented headwall and cemented pipe bottom to resist abrasion.

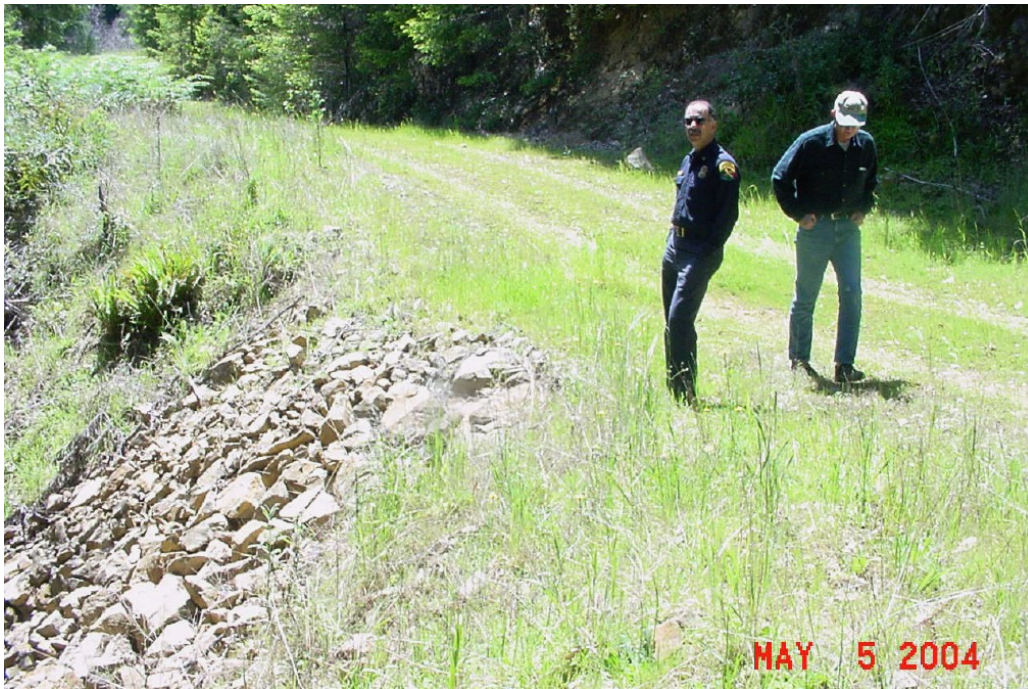
Stop 4. Mendocino Redwood Company (MRC)—North Fork of Big River, Entrance THP 2001 (Figure 5). The group observed two sites where 18 inch culverts were removed from small Class III watercourses and dips with rocked outfalls were installed three years ago. The road was outsloped with dips and inside ditches were removed as part of the THP work. Rob Rempel stated that MRC is attempting to use fewer culverts where possible, reducing maintenance requirements and long-term crossing failure potential. He estimated that these dipped crossings cost only \$800 to \$1000, but the critical factor for cost is the distance to the rock pit. It is very important to have the rip-rapped outlet extend up to the elevation of the road surface to prevent backcutting. It is also essential to dip the road out so that there is a positive grade on the downhill side of the crossing, preventing water from running down the road surface. In general, one to three loads (10 to 30 cubic yards) of rock are required for these types of outlets. On steeper slopes, a key way is cut with an excavator and rock is placed on the slope with the excavator. These types of crossings, or rocked ford crossings for larger drainages, can be cost effective in the long-term, since annual maintenance is reduced and pipes do not need to be replaced every 25 years. Tom Schultz emphasized that these crossings are more appropriate for seasonal and temporary roads that are not used or generally observed in the winter period.

Figure 5. MRC (stop 4). Dipped Class III crossing where an 18 inch CMP was removed and a rocked outfall was installed.

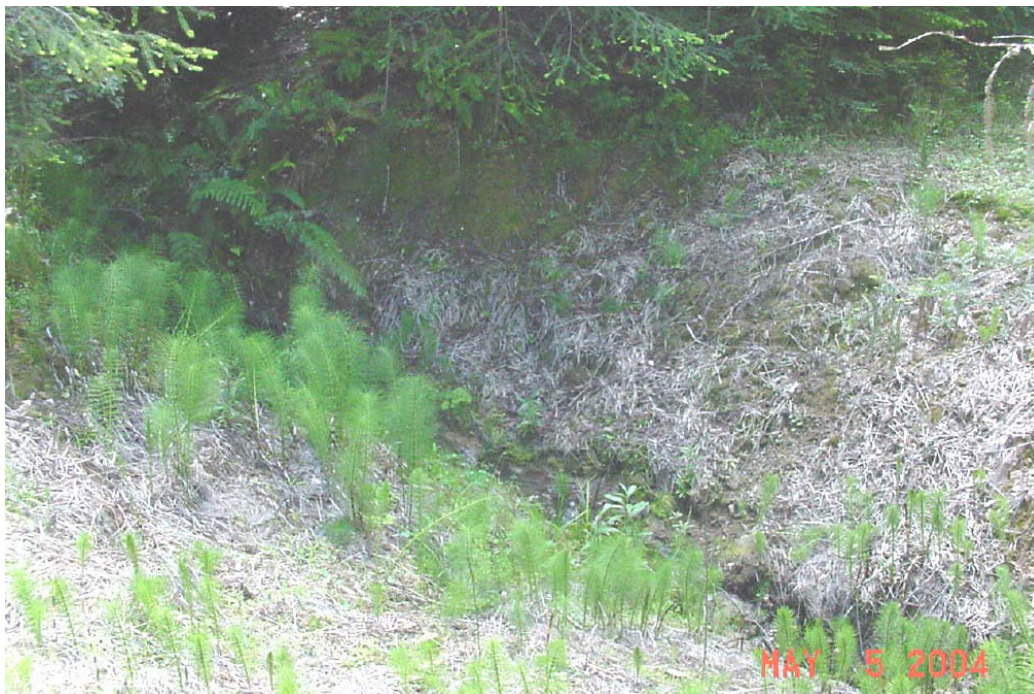
Stop 5. Mendocino Redwood Company (MRC)—East Branch of the North Fork of Big River, Pits THP 2001 (Figure 6). An abandoned Class II watercourse crossing was observed. Rob Rempel stated that this site had a partially plugged 36 inch CMP and 18 inch backup culvert in place prior to abandonment. The excavator operator and RPF looked carefully for the natural channel bottom when the work was completed in 2001 and determined that they had successfully located the old channel elevation. After three winter periods, very little downcutting or backcutting has taken place. The sides of

the excavation were sloped back and mulched with straw. Spoils from the operation were placed just up the old road, compacted, and treated to reduce surface erosion. The excavated channel bottom was not armored with rock since it was determined that the old channel surface had been located. Mr. Rempel estimated that this operation only cost approximately \$500-600. Additionally, approximately 1300 feet of road were abandoned above and below this crossing. At the entrance to the main road, very heavy concentrations of wood and slash were applied to keep traffic off the abandoned road.

Figure 6. MRC (stop 5). Abandoned Class II watercourse crossing showing almost no downcutting after three winter periods.

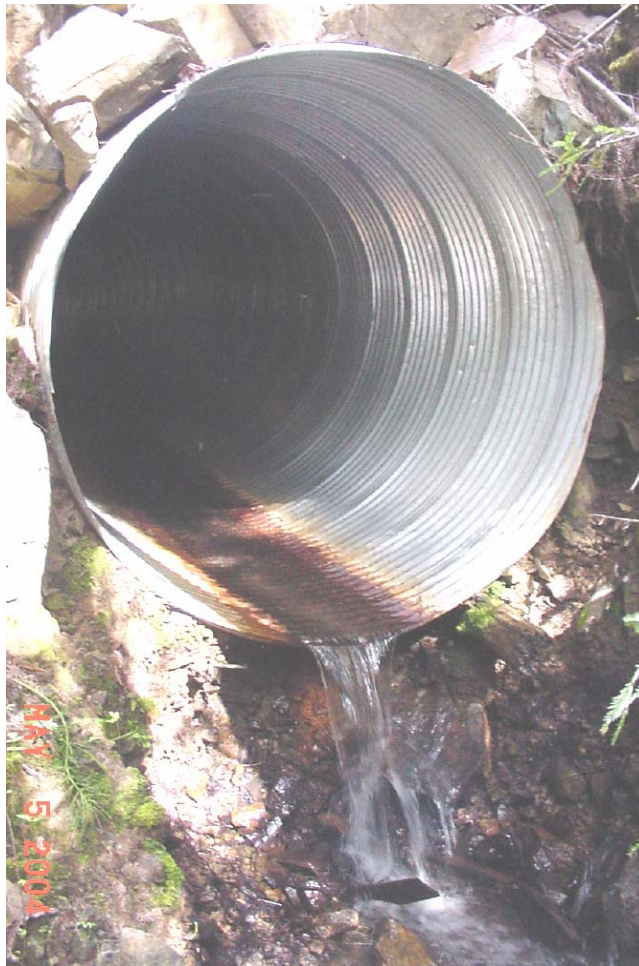
Stop 6. Campbell Timberland Management (CTM)—Two Log Creek mainline haul road (Figure 7). An 84 inch culvert installed in 1998 on a Class II watercourse was observed. Peter Ribar stated that previously this site had an old Humboldt crossing that was failing. The inlet and outlet are heavily armored with rock. Fill was removed to eliminate the flat grade and allow the road to drop into and pull out of the crossing—removing diversion potential at this site. It was thought that this tributary to Two Log Creek, which flows into Big River, was a restorable Class I watercourse, but the lower end of the culvert was placed about two feet higher than the stream channel, preventing the possibility of fish passage. CTM biologists, however, question the assumption that this small tributary actually has fish habitat due to its steep gradient.

Figure 7. CTM (stop 6). Class II 84 inch pipe outlet without fish passage.

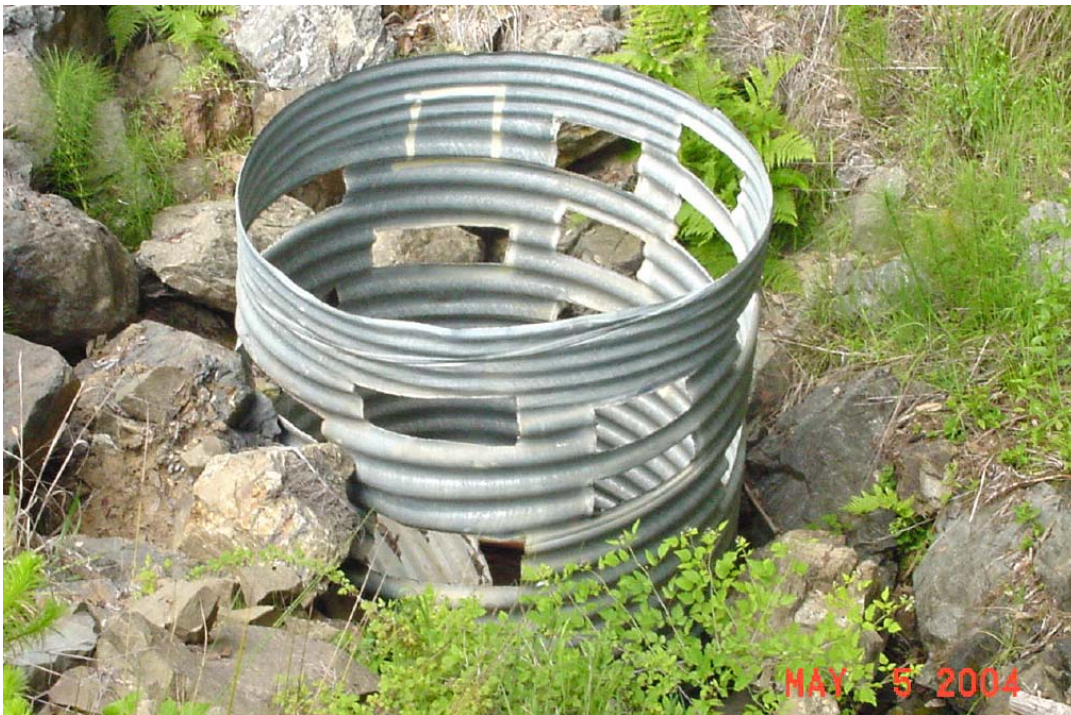
Stop 7. Campbell Timberland Management (CTM)—Two Log Creek mainline haul road (Figure 8). A 60 inch CMP on a Class II watercourse was observed and discussed. Peter Ribar stated that prior to recent work, there was extensive ditchline erosion. Work done about six years ago redirected ditch flow onto a rocked apron which successfully arrested the erosion problem. Extensive sediment and woody debris upslope of the pipe inlet was addressed through the installation of jetty size rip-rap/rock buttressing around the pipe inlet. Additionally, an 84 inch mitered, slotted standpipe was installed over the pipe inlet as a retrofit to increase inlet capacity. Currently the 60 inch CMP inlet area is about half full of sediment and should be cleaned. Stephen Levesque stated that when large pipes are installed under significant fills, consider using a lower gauge metal (lower number = thicker metal). Additionally, aluminizing the pipe at the factory can extend the useful life of the structure by 5 to 10 years.

Figure 8. CTM (stop 7). 60 inch CMP with 84 inch standpipe; heavy boulder rip-rap.

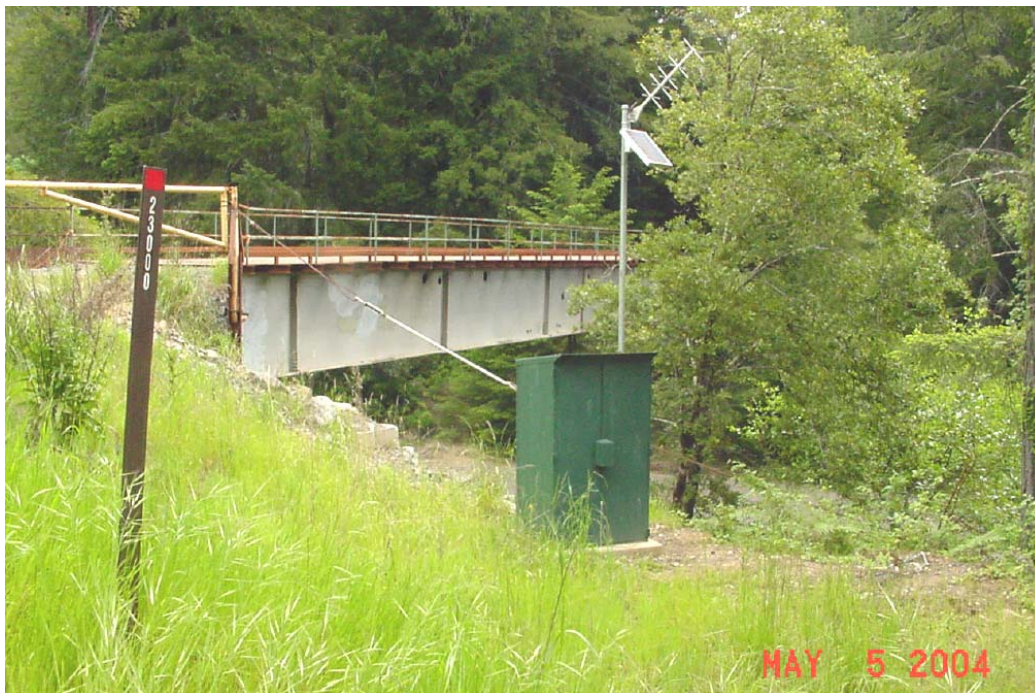
Stop 8. Campbell Timberland Management (CTM)—Two Log Creek mainline haul road; bridge over Big River (Figure 9). A 110 foot bridge was observed and discussed. Previously, a low water crossing was used in the summer period. Peter Ribar stated that concrete footings are in place and this structure cost over \$120,000 to construct. The USGS operates a gaging station immediately downstream from this bridge on Big River and the flow during the field trip was about 28 cfs.

Figure 9. CTM (stop 8). Bridge over Big River and USGS gaging station.

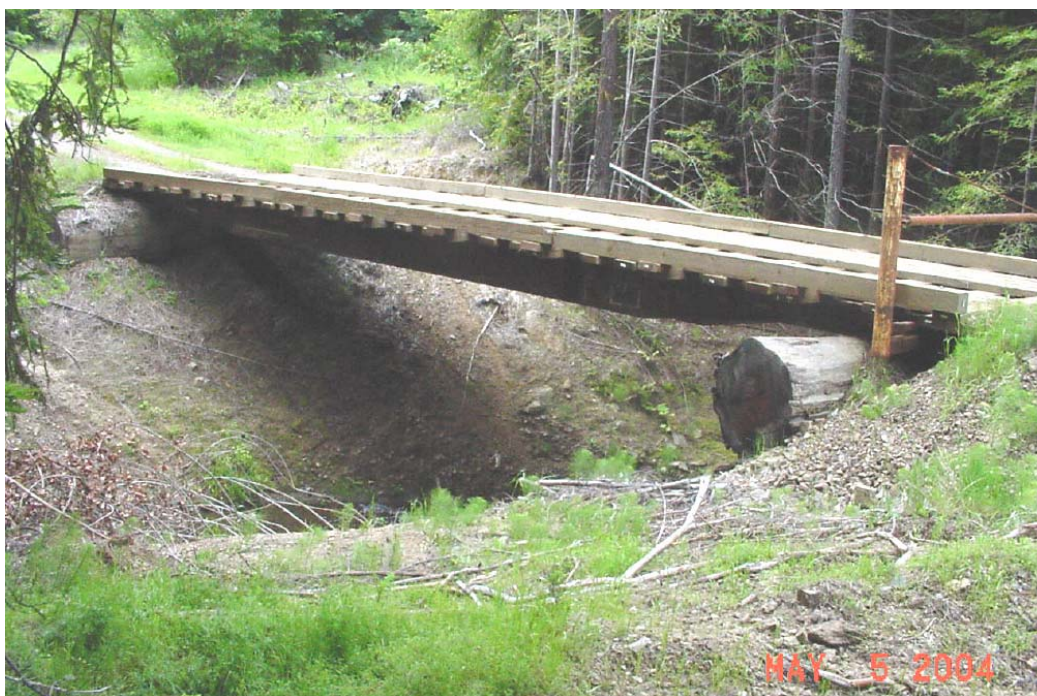
Stop 9. Mendocino Redwood Company (MRC)—Two Log Creek mainline haul road (Figure 10). A 62 foot railcar bridge installed by MRC in 2001 was very briefly observed. It replaced a log stringer ridge over Two Log Creek and log abutments are in place.

Figure 10. MRC (stop 9). Railcar bridge installed over Two Log Creek.

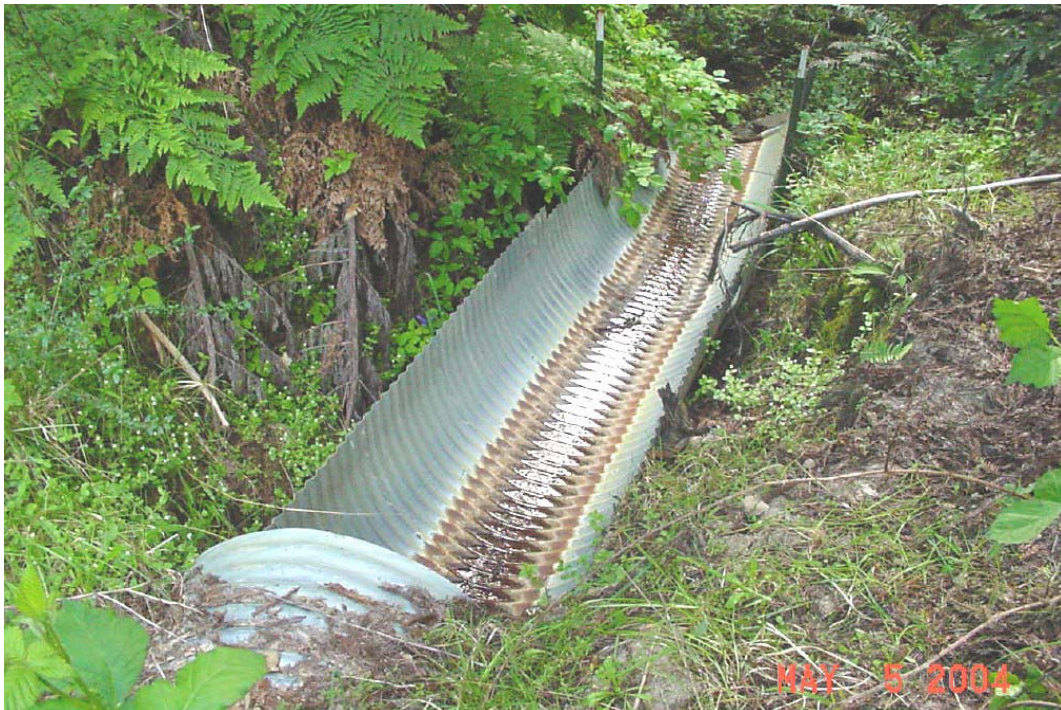
Stop 10. Campbell Timberland Management (CTM)—Two Log Creek mainline haul road (Figure 11). A 36 inch CMP on a Class III watercourse with a half-round downspout and rocked armor outfall was observed. This structure is six years old and operating without problems. Stephen Levesque and Peter Ribar discussed compaction standards and pipe installation requirements on CTM-Hawthorne timberlands.

Figure 11. CTM (stop 10). A 36 inch CMP on a Class III watercourse with a half-round downspout and rocked armor outfall.
